Manhole Inspection Summary

Manhole # S07WW_008MH

Insp Date: **7/21/08 9:33 AM**

Location Address: **3700 LIBERTY HEIGHTS AVE**

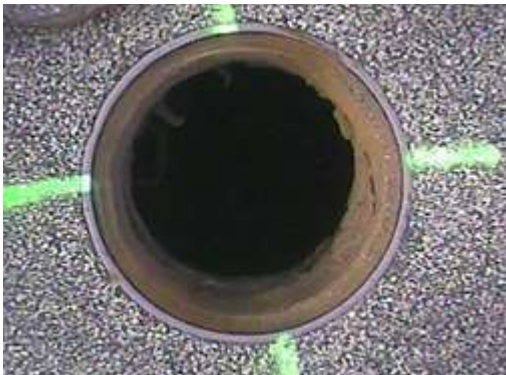
Top View

Abandoned pipe @ 9 O' clock

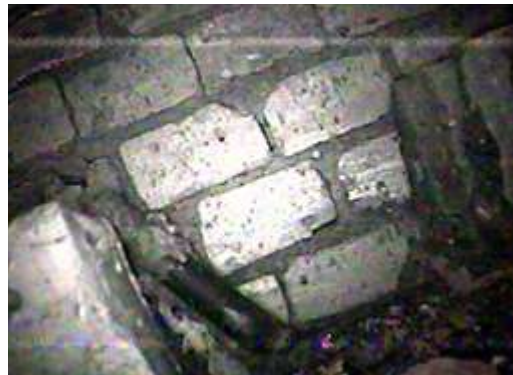
Defect 1

Count: **6** Missing: **1** ☒ **Corroded**

CORRODED/MISSING RUNG

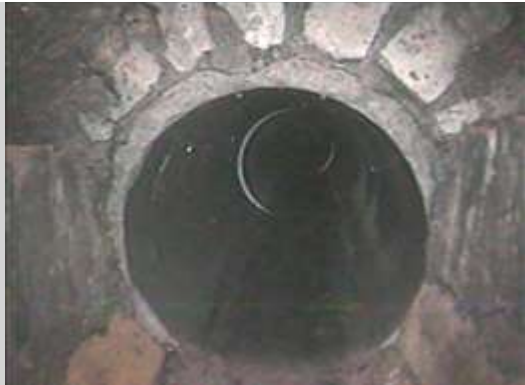
6 O'Clock Inflow

Infiltration: **None** Pipe Seal Cond: **Broken**

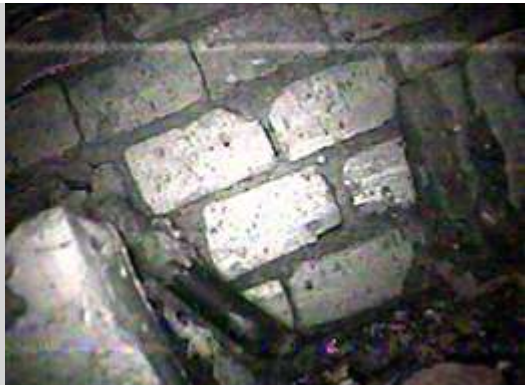
9 O'Clock Inflow

Connects To: **Stub connection / abandoned**
